Klub Gazety Polskiej w Aarhus
zaprasza na spotkanie
z **Glennem A. Jørgensenem**.

Agenda of Today's Meeting

This document is an English translation of the Final Report on the accident on 10 April 2010, on Smolensk "Severny" airdrome, to the Tupolev Tu-154M tail number 101 of the Republic of Poland.

Wreckage plot of the Tupolev Tu-154M No.101 aircraft

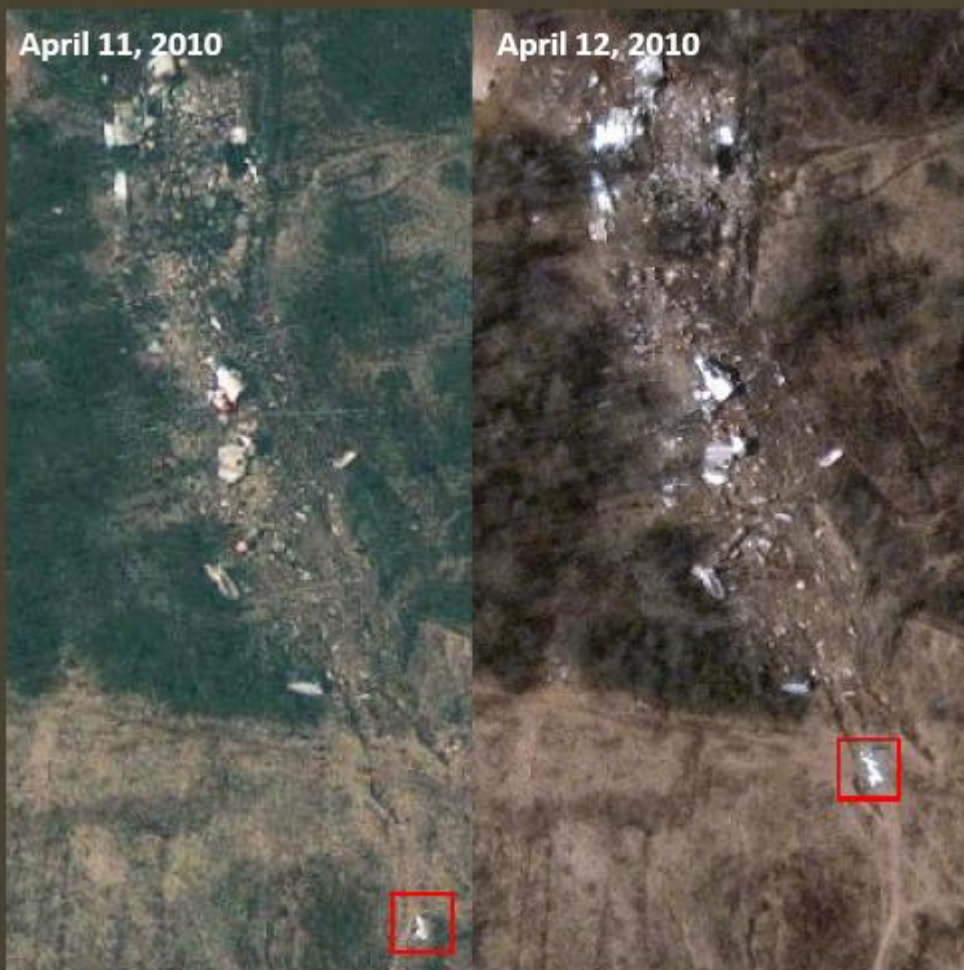
The plane's left horizontal stabilizer position on satellite pictures

- The left horizontal tail surface disengaged from the airplane more than 70m prior to the site of crash and was moved on the night between the 11th of april and 12th of april 35m closer to the site of crash according to satellite photos.

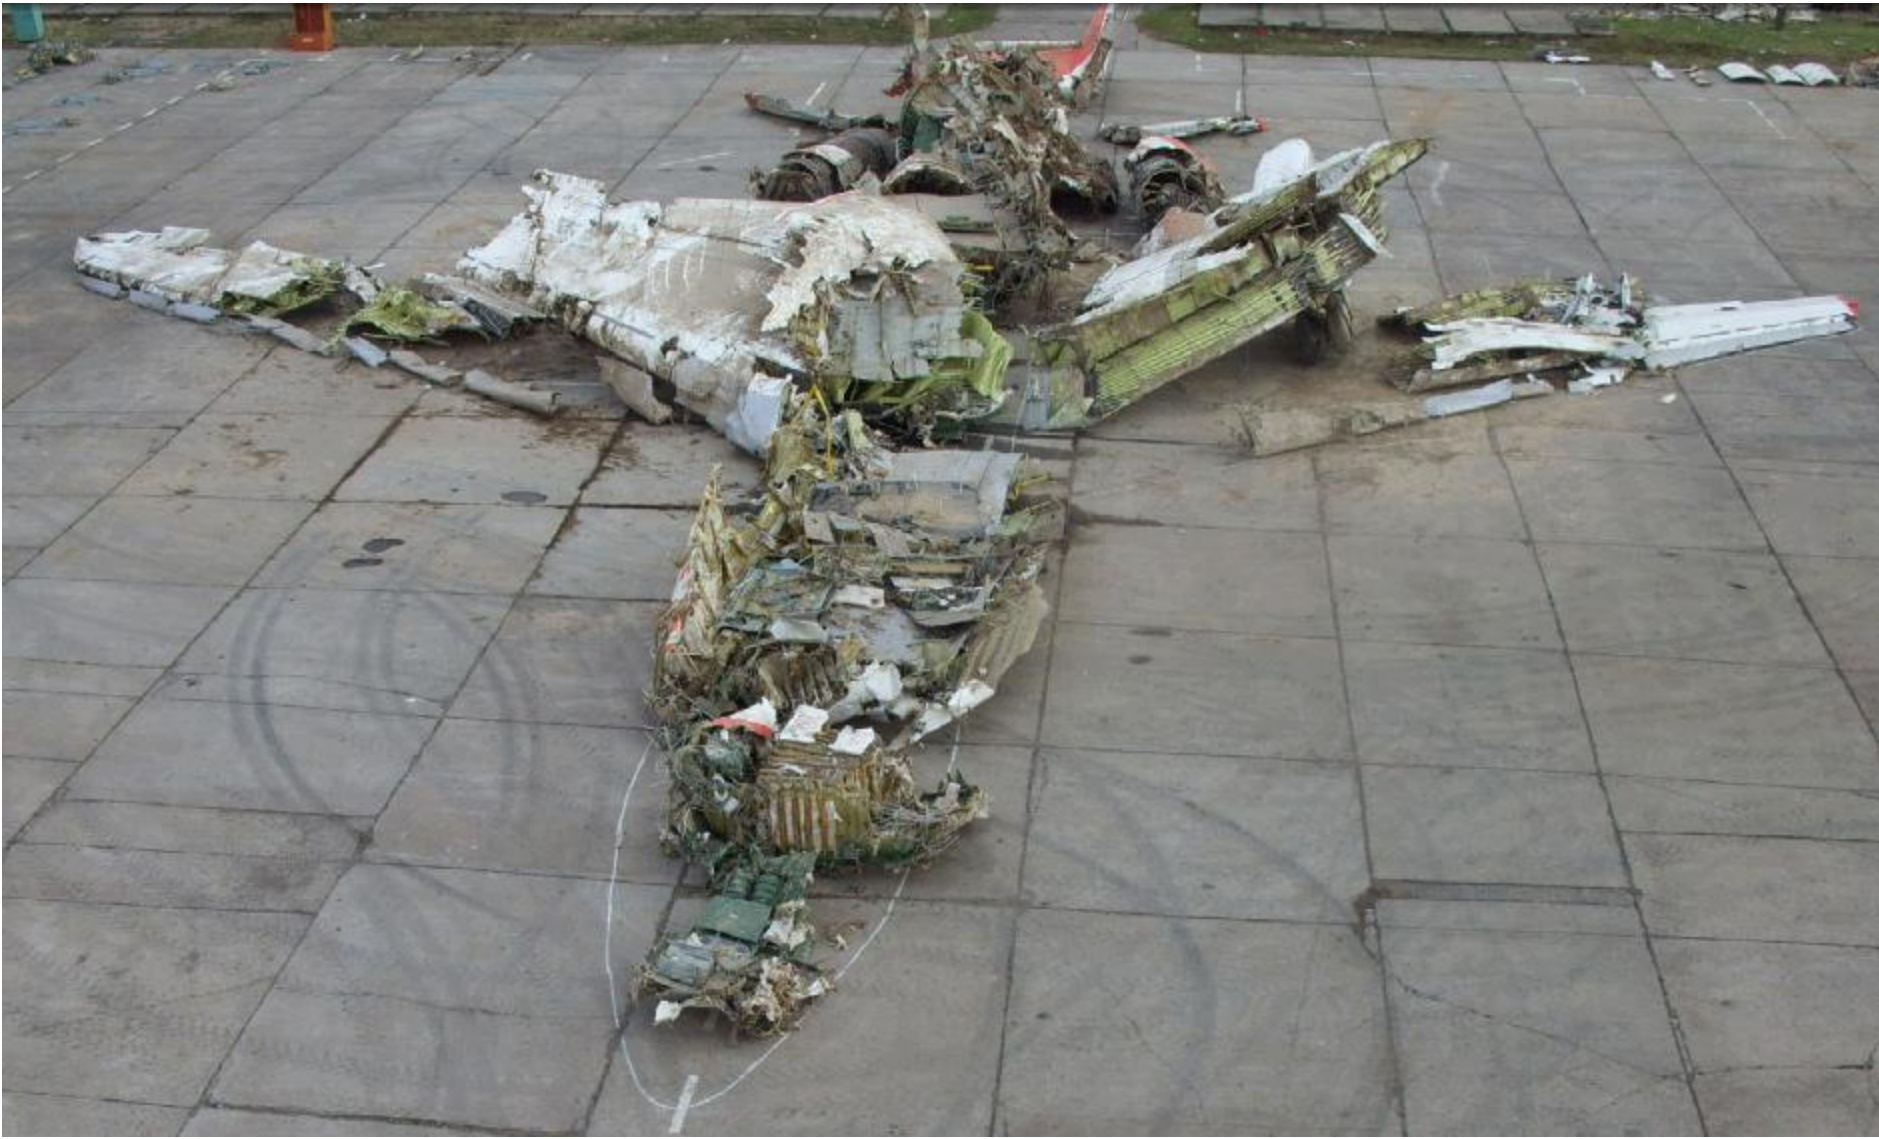
The parts never found are indicated with white. This picture speaks for itself.

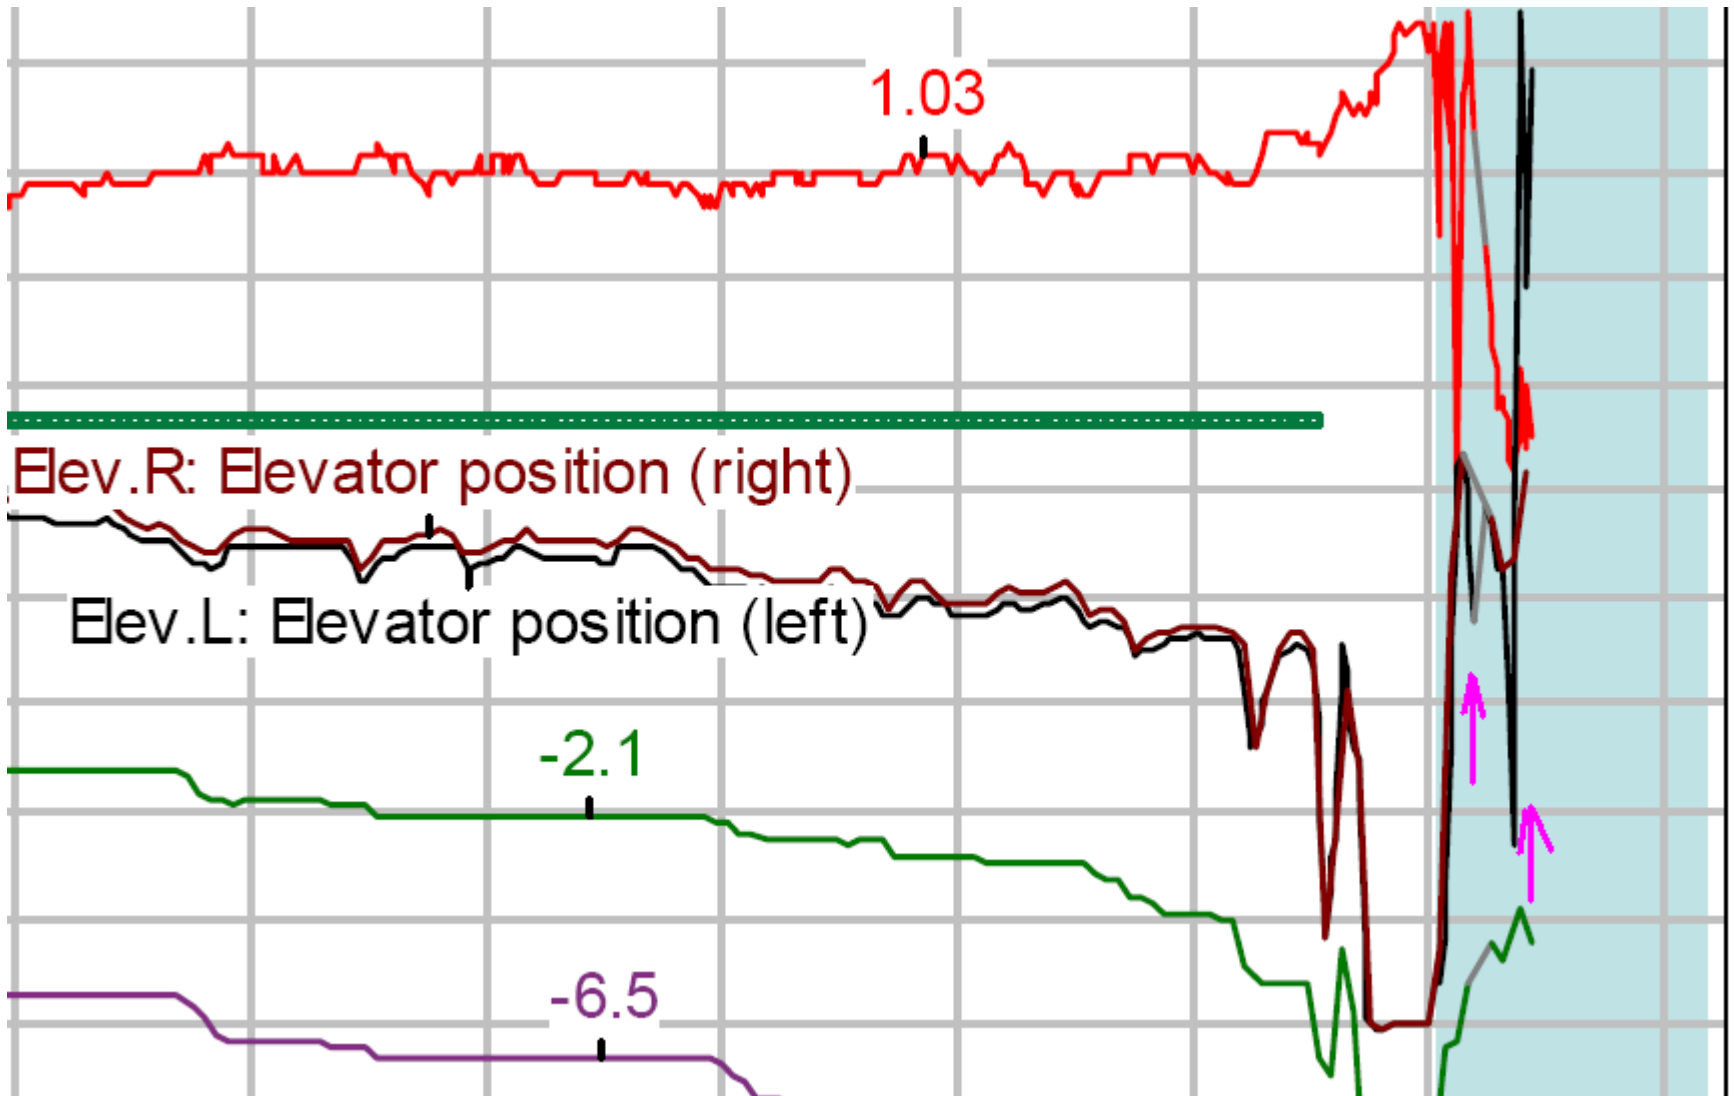
The Recorded Vertical Acceleration. Note the two distinct drops in vertical acceleration.

POINT OF ADDITIONAL
WING LOSS

LOSS OF
WING TIP

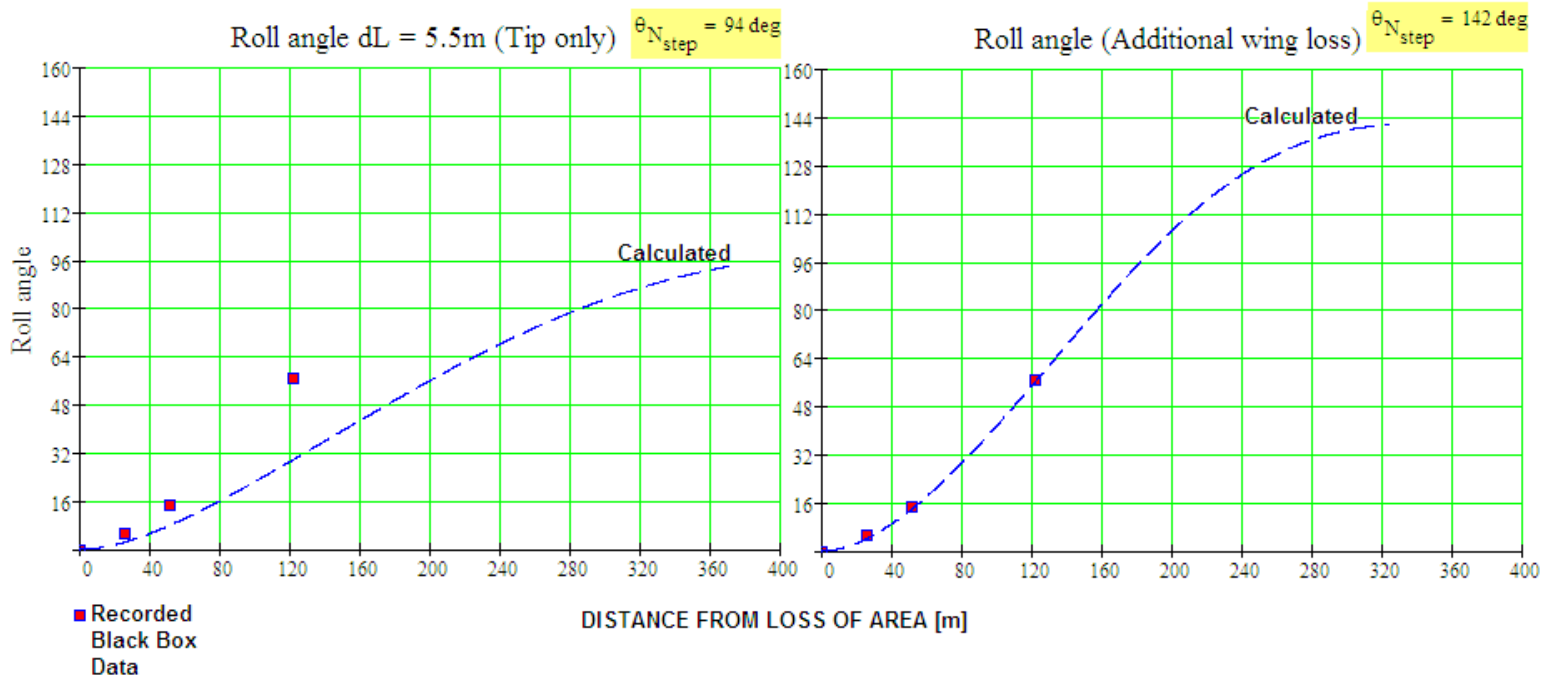
VERY CONSERVATIVE SIMULATION BASED ON INPUT FROM KOWALECZKO.

Exaggerated lift loss = 9% (corresponds to about 10% lift loss by CFD method)

The squares are recorded roll angles as pr. black box data. Lines are simulated roll angles.

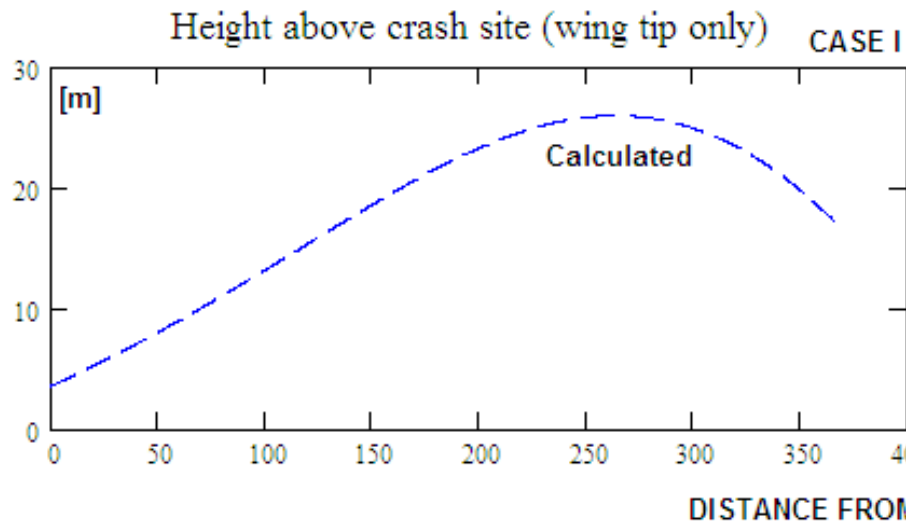
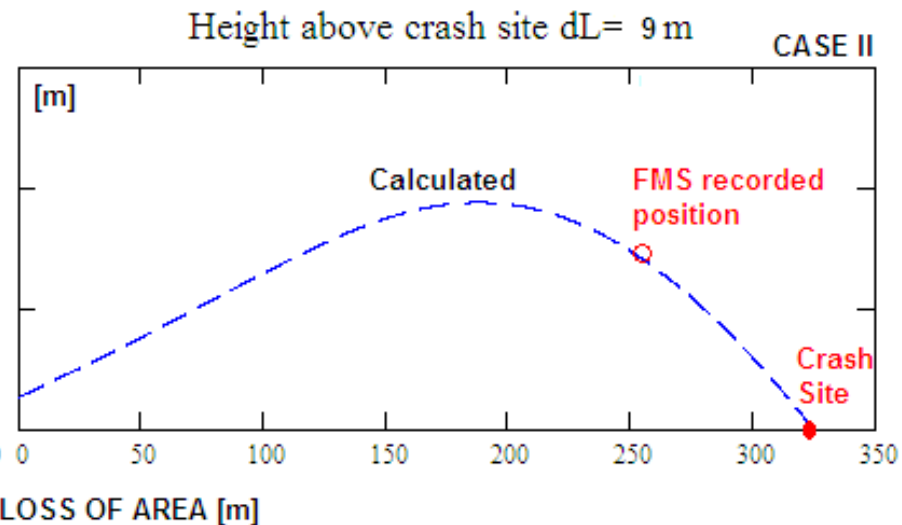
Left figure: The simulated height above the crash site in case of wing tip loss only assuming exaggerated lift loss conditions.

Right figure: The simulated height above the crash site assuming the additional loss of 15m² wing area 47m further downstream at the point of the second dip in recorded vertical acceleration.

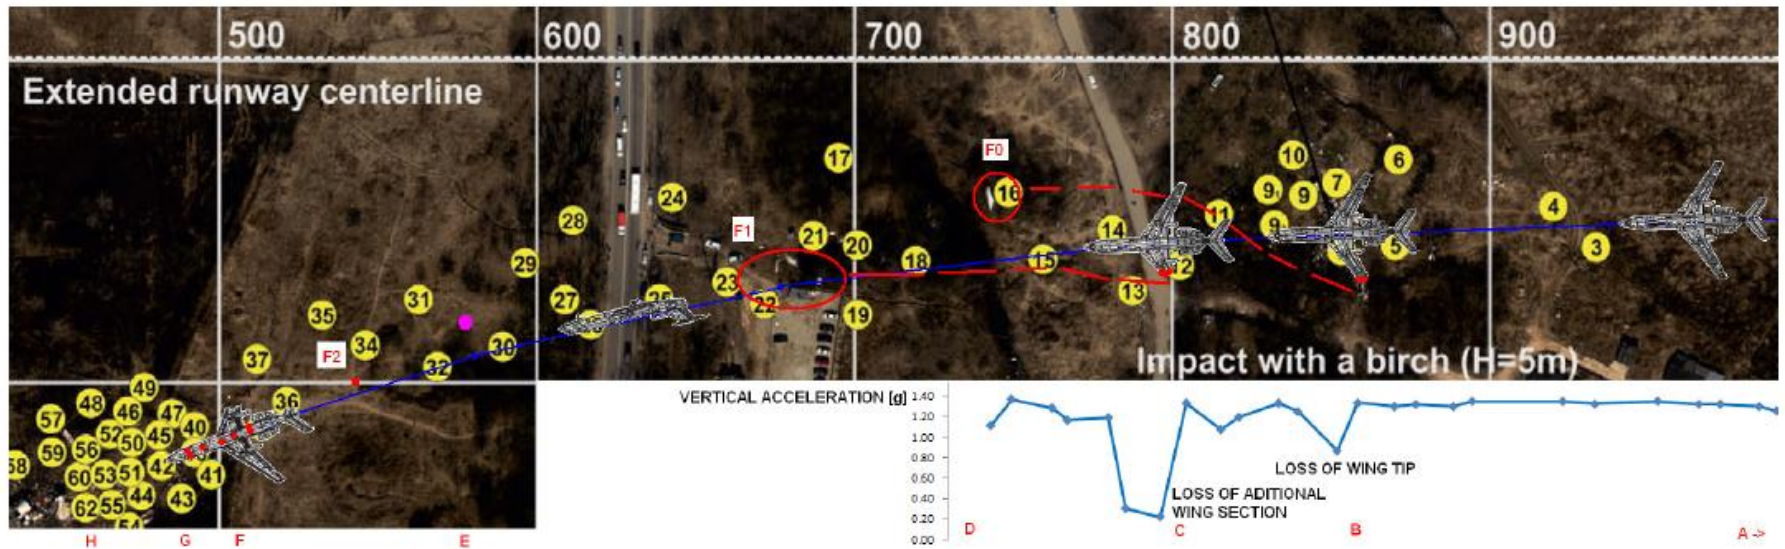
Figure 9. The found height trajectory together with the measured vertical acceleration (G-force) as a function of lateral position assuming the first impact took place at the lateral position of the birch tree of interest.

20	Fragment of left slat №23 drawing. 154.8336.23.100.
21	Fragment of left slat, flap carriage, left wing deflector.
22	Fragment of inner flap of the left wing.
23	Fragment of the left wing in the tree trunk.
24	Fragment of left wing flap.

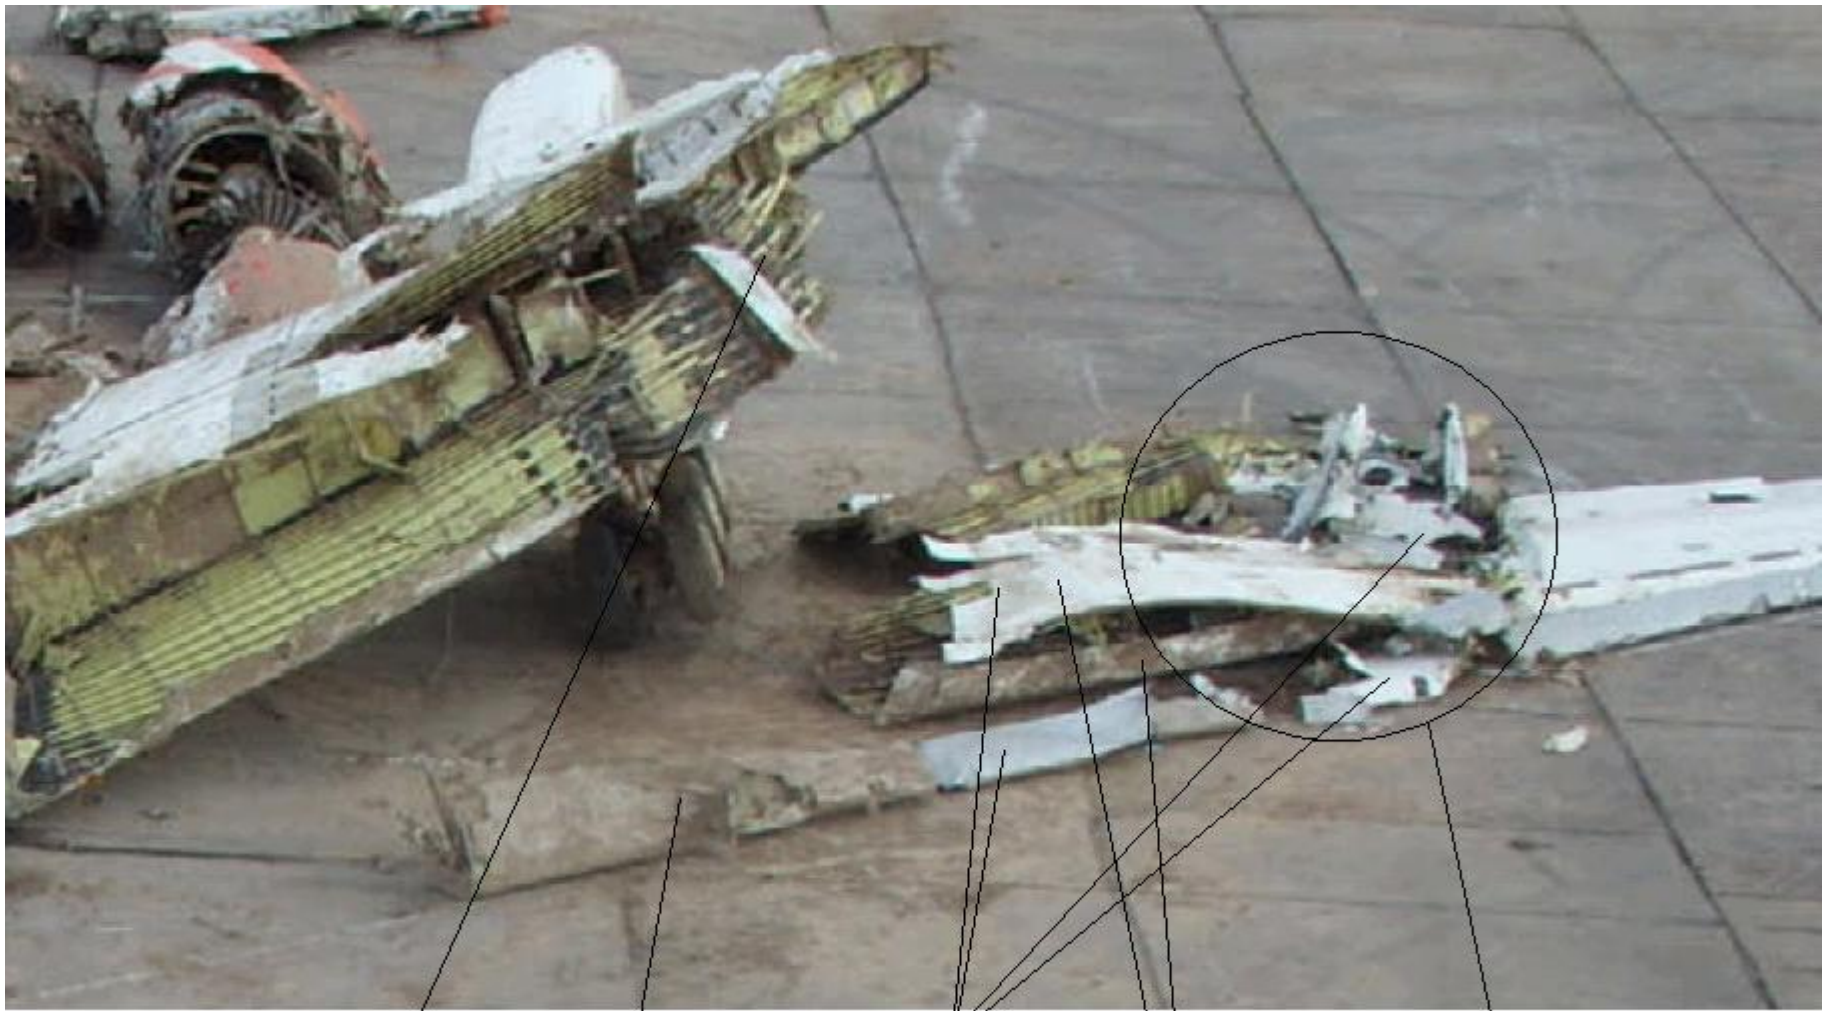
Bent backwards

Soiled part

Clean parts

Straight sections

Debris

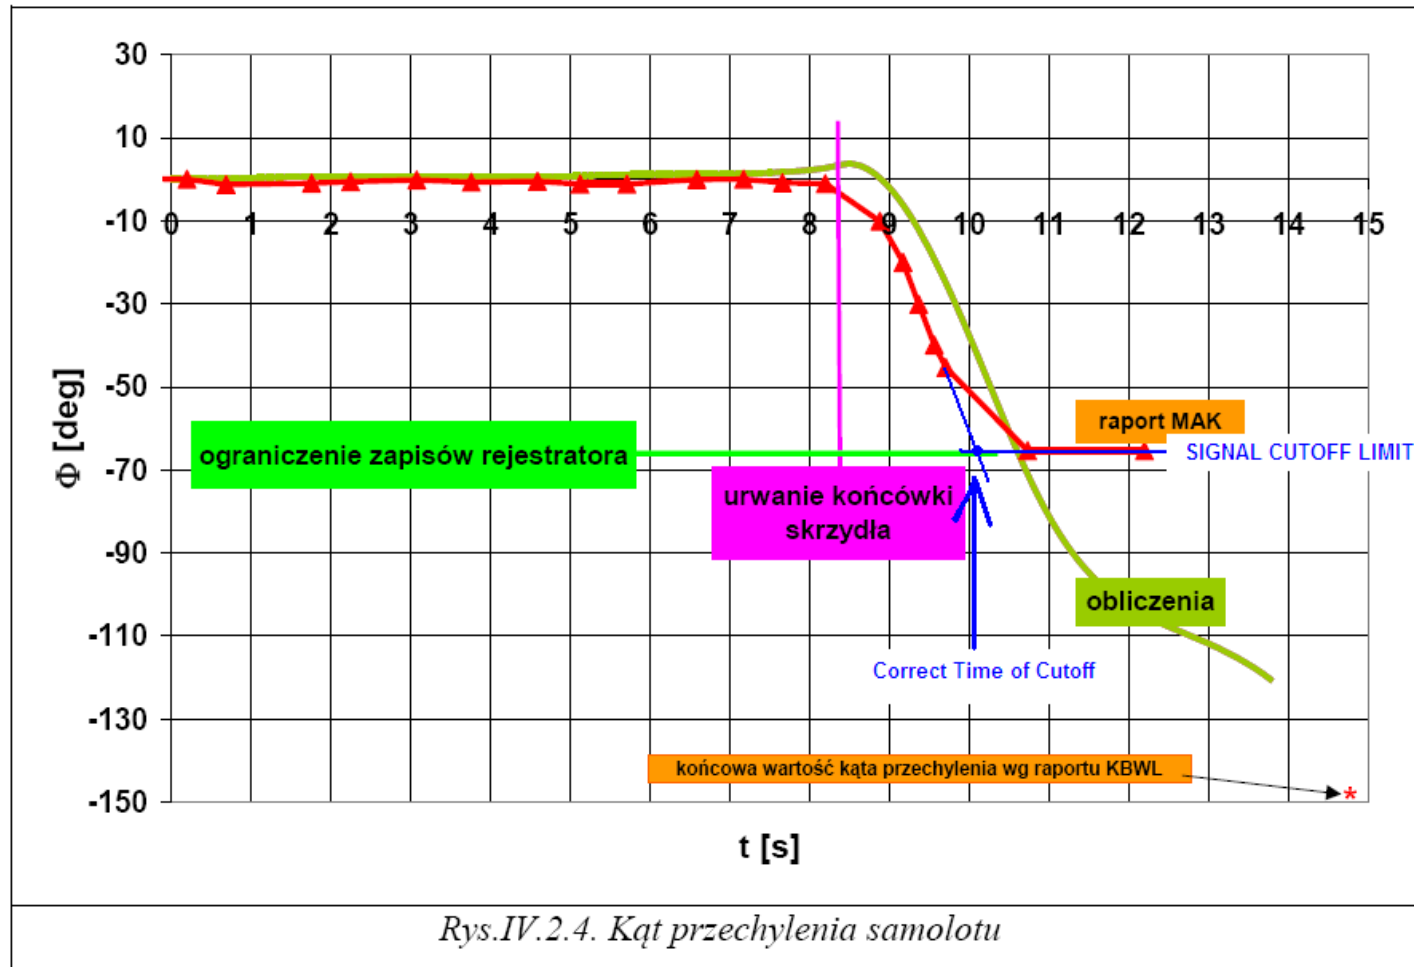
COMPARISON OF ROLL ANGLE BY KOWALECZKO AND GAJ

- The final recorded roll angle of the P101 cannot be explained by my simulations NOR by Proffessor Kowaleczko!

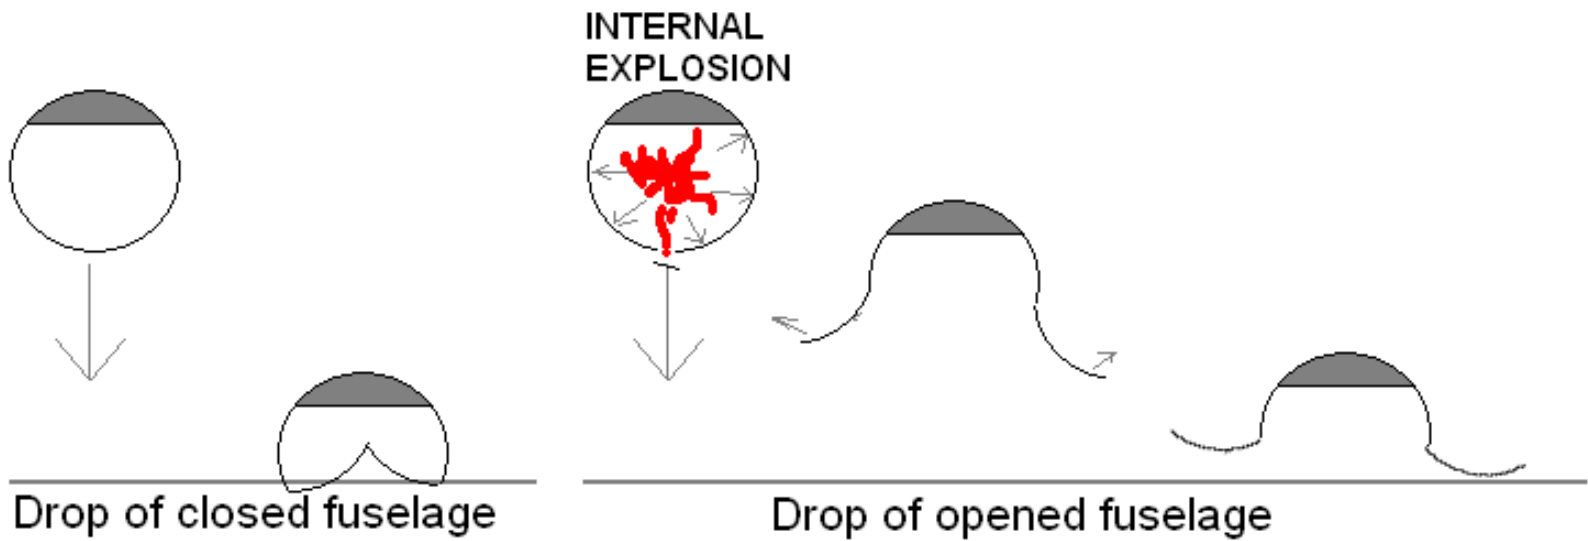
A section of the fuselage of P101 was found in the state shown to the right. Simulations show this only occurs in case the fuselage has been opened prior to final ground contact.
