Klub Gazety Polskiej w Aarhus
zaprasza na spotkanie
z **Glennem A. Jørgensenem**.

Agenda of Today's Meeting

This document is an English translation of the Final Report on the accident on 10 April 2010, on Smolensk "Severny" airdrome, to the Tupolev Tu-154M tail number 101 of the Republic of Poland.

Wreckage plot of the Tupolev Tu-154M No.101 aircraft

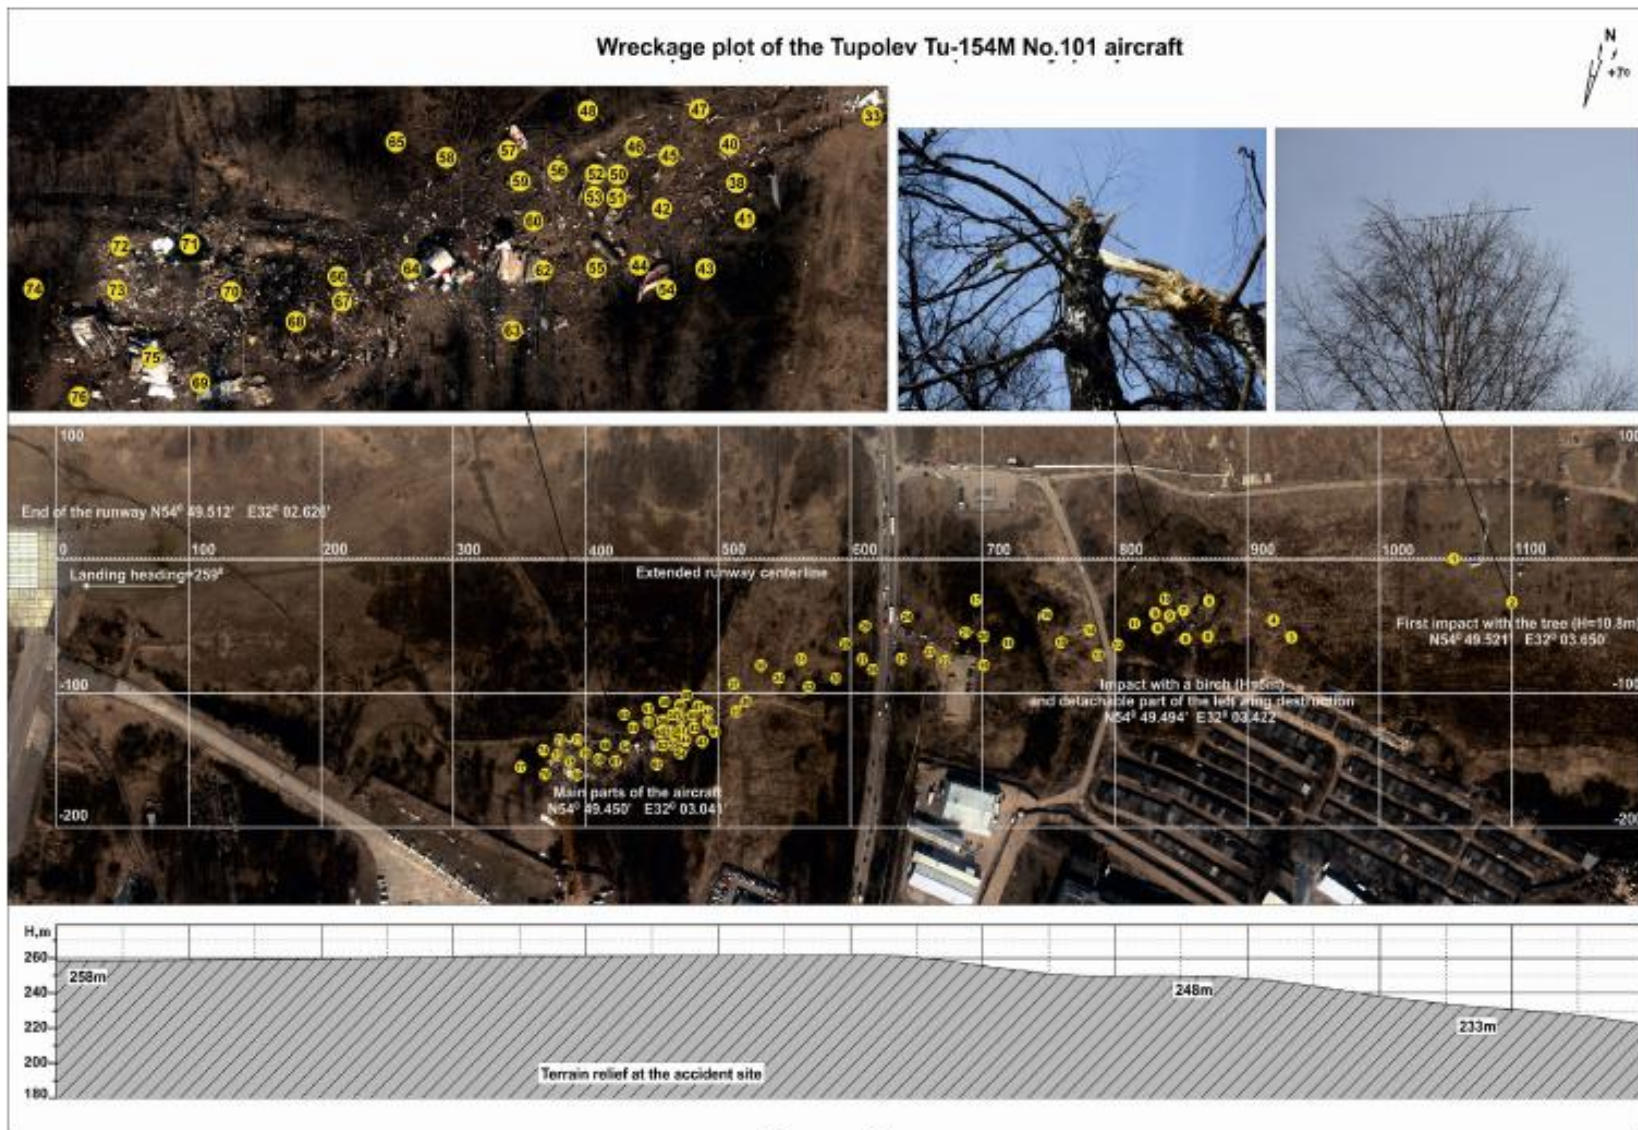
Figure 35

The parts never found are indicated with white. This picture speaks for itself.

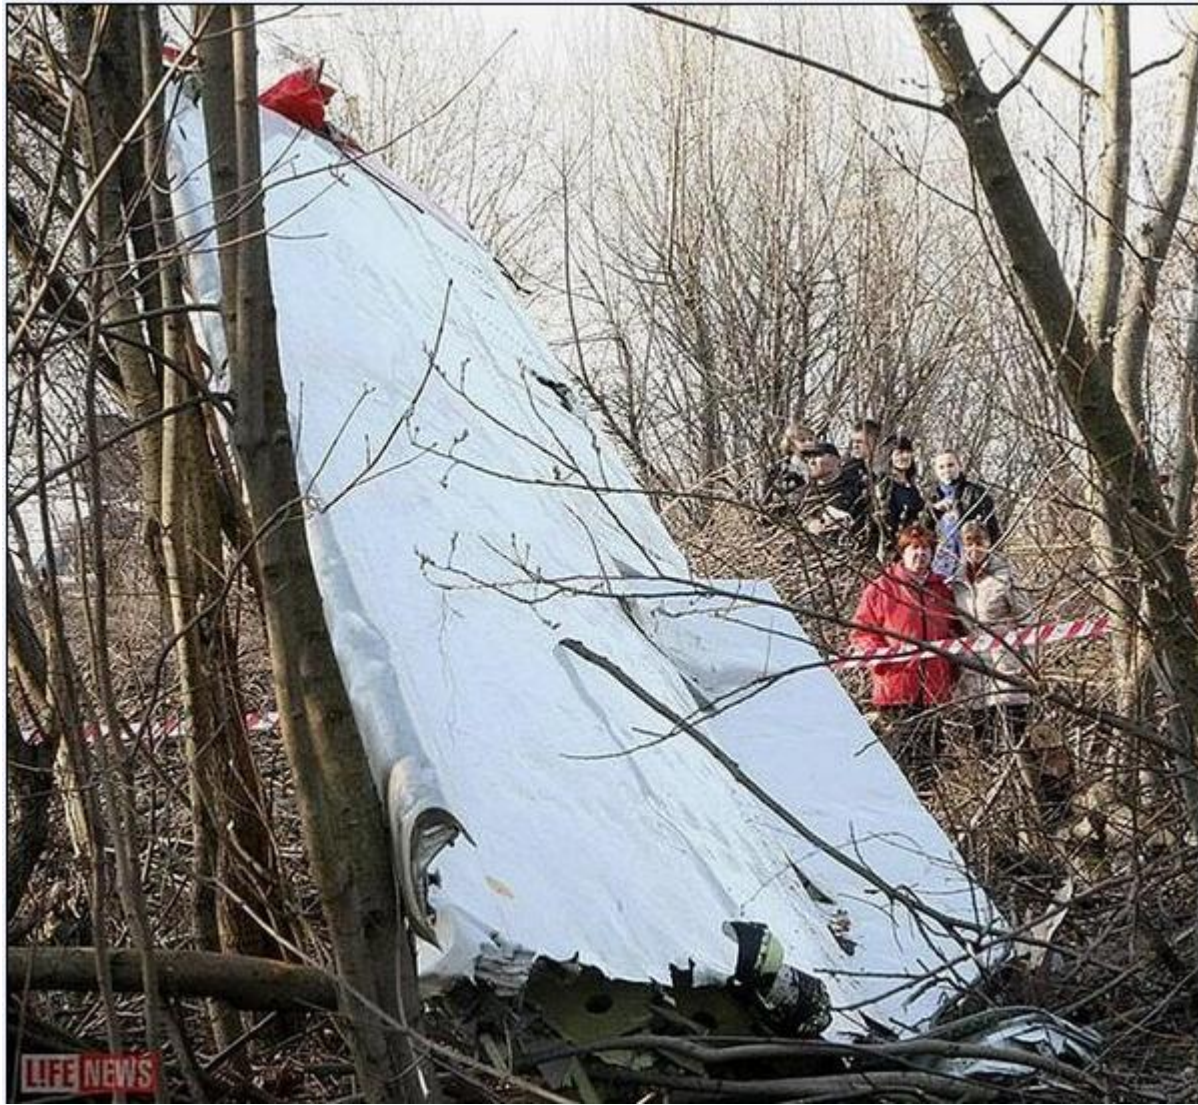
End of Slats is not delmolished by the Birch at all. This is physical impossible had the wing hit the Tree.

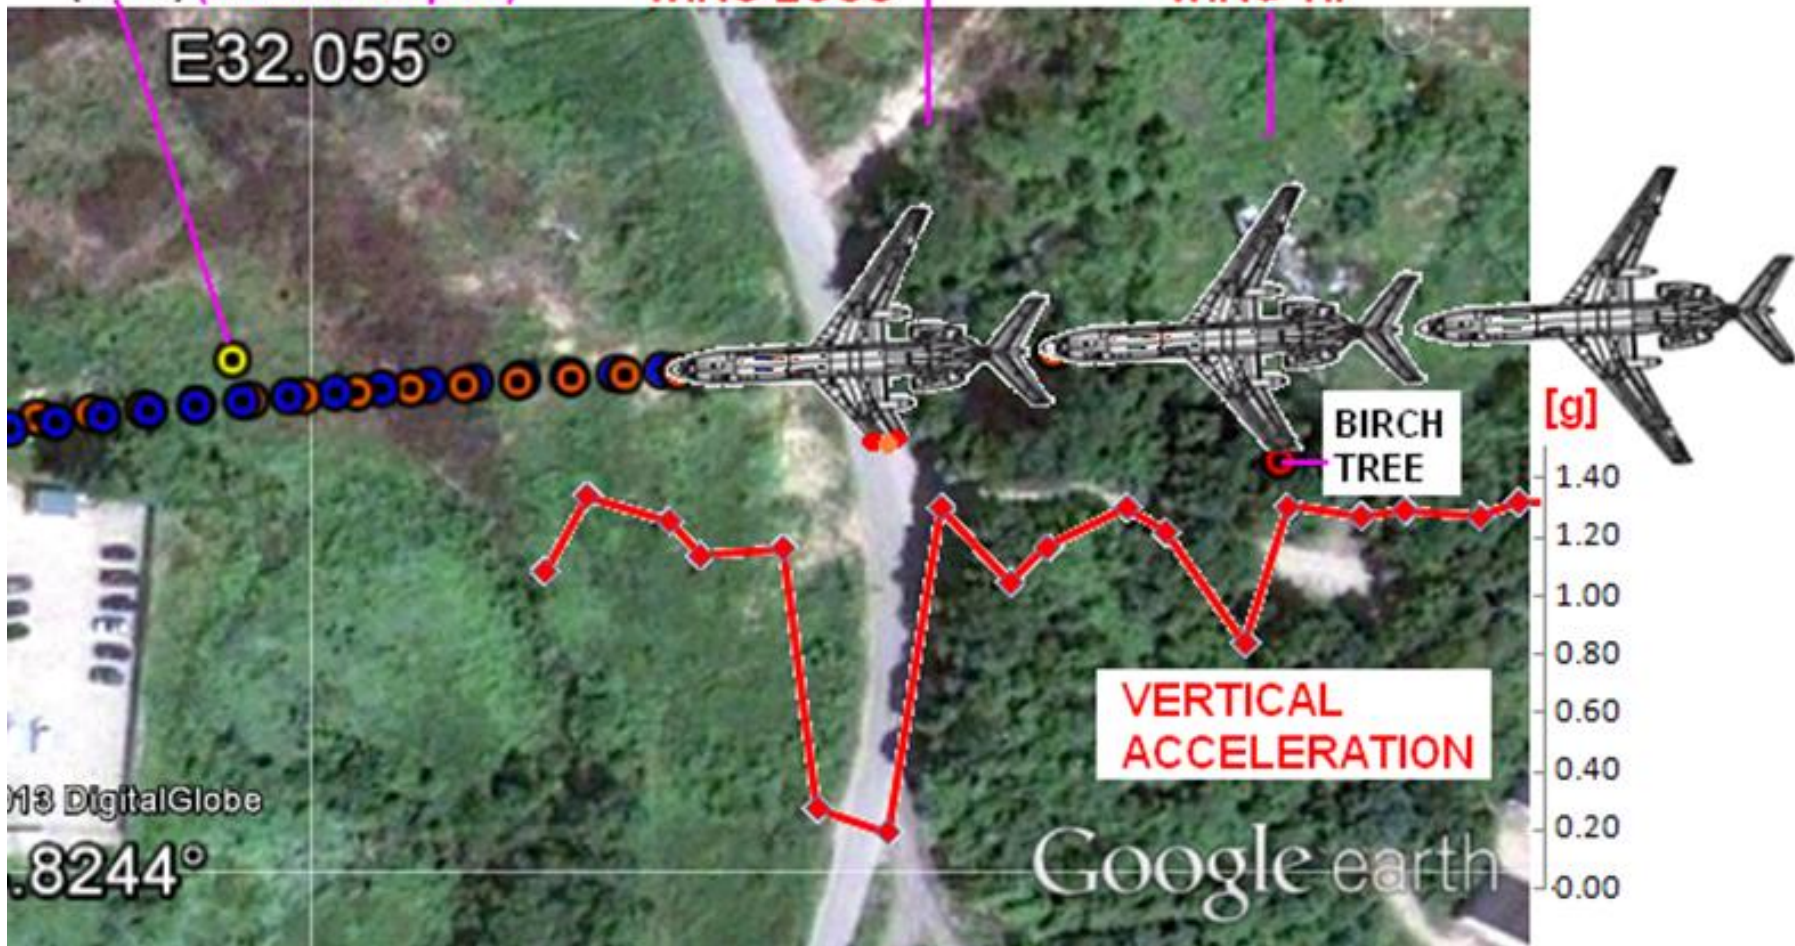
TAWS 38
(GPS) (Measured pos)

POINT OF ADDITIONAL
WING LOSS

LOSS OF
WING TIP

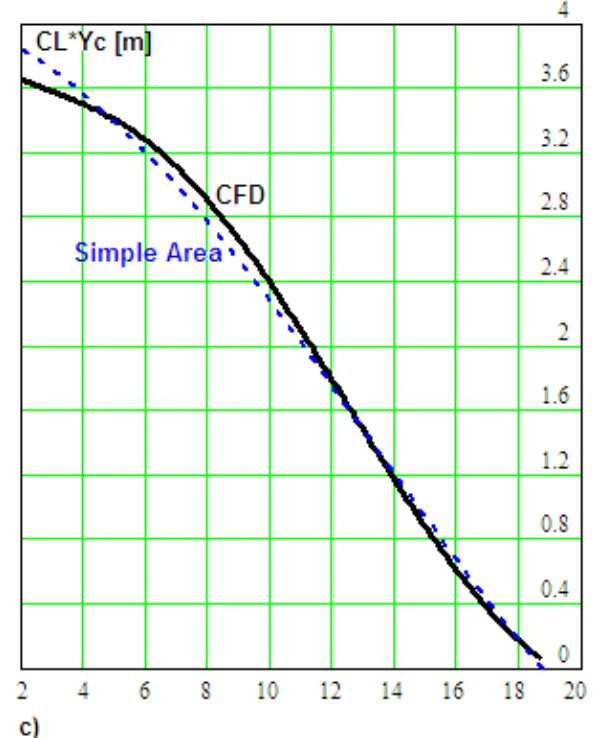
RESULTING ROLL MOMENT

VERY CONSERVATIVE SIMULATION BASED ON INPUT FROM KOWALECZKO.

Exaggerated lift loss = 9% (corresponds to about 10% lift loss by CFD method)

No Slats

Underestimated chord length (width of wing).

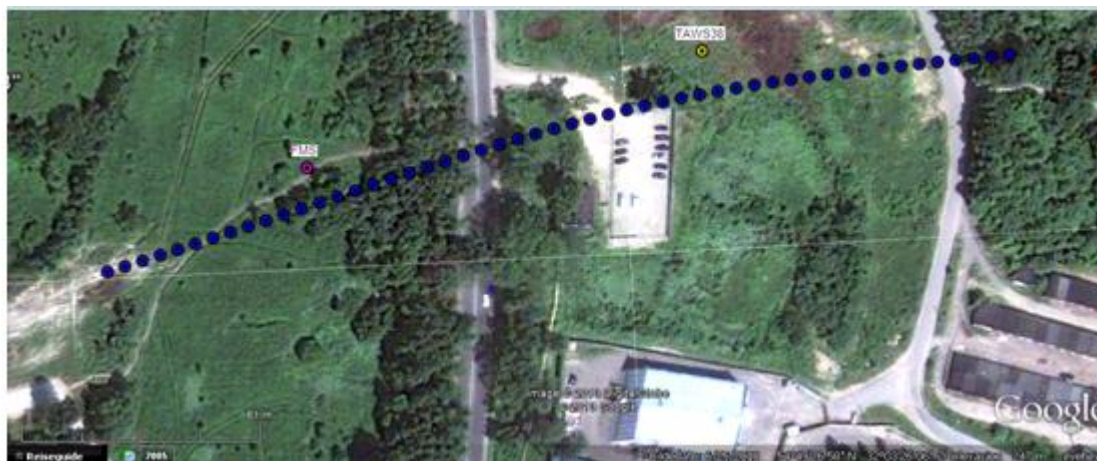
Reported Wing Fragment Locations

20	Fragment of left slat №23 drawing. 154.8336.23.100.
21	Fragment of left slat, flap carriage, left wing deflector.
22	Fragment of inner flap of the left wing.
23	Fragment of the left wing in the tree trunk.
24	Fragment of left wing flap.

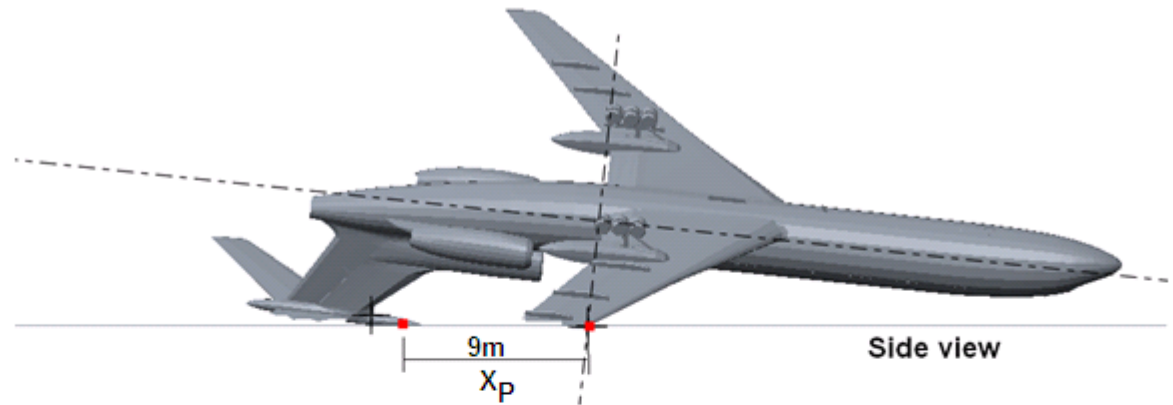
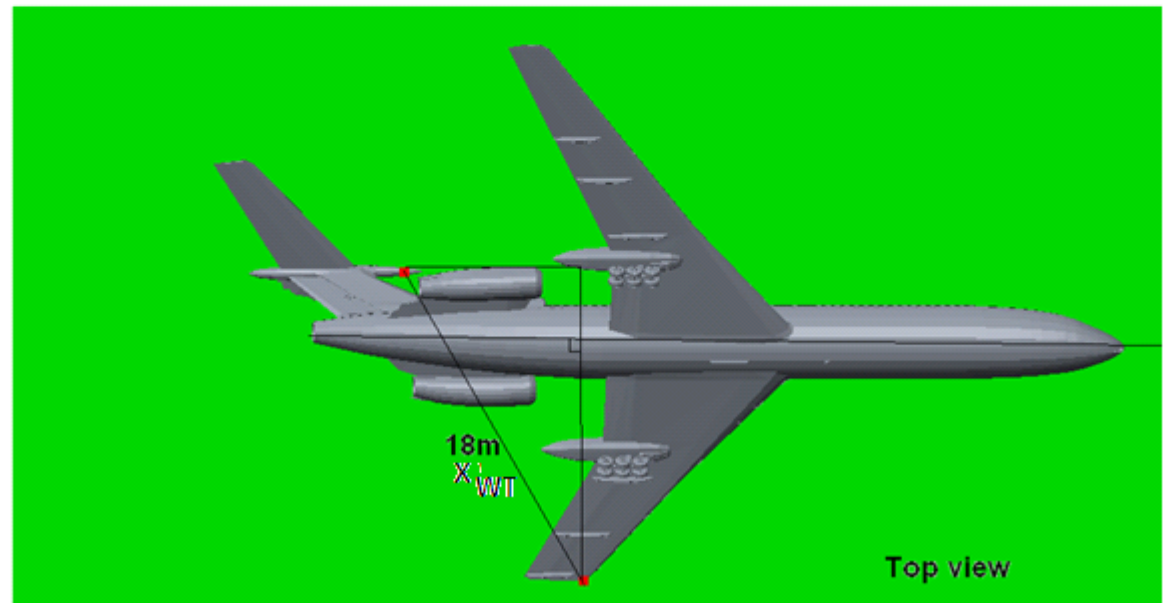
ORIENTATION OF PLANE AT CRASH (MAK)

- 150° ROLL,
- -6 ° INCLINATION,
- ONLY LOSS OF WING TIP

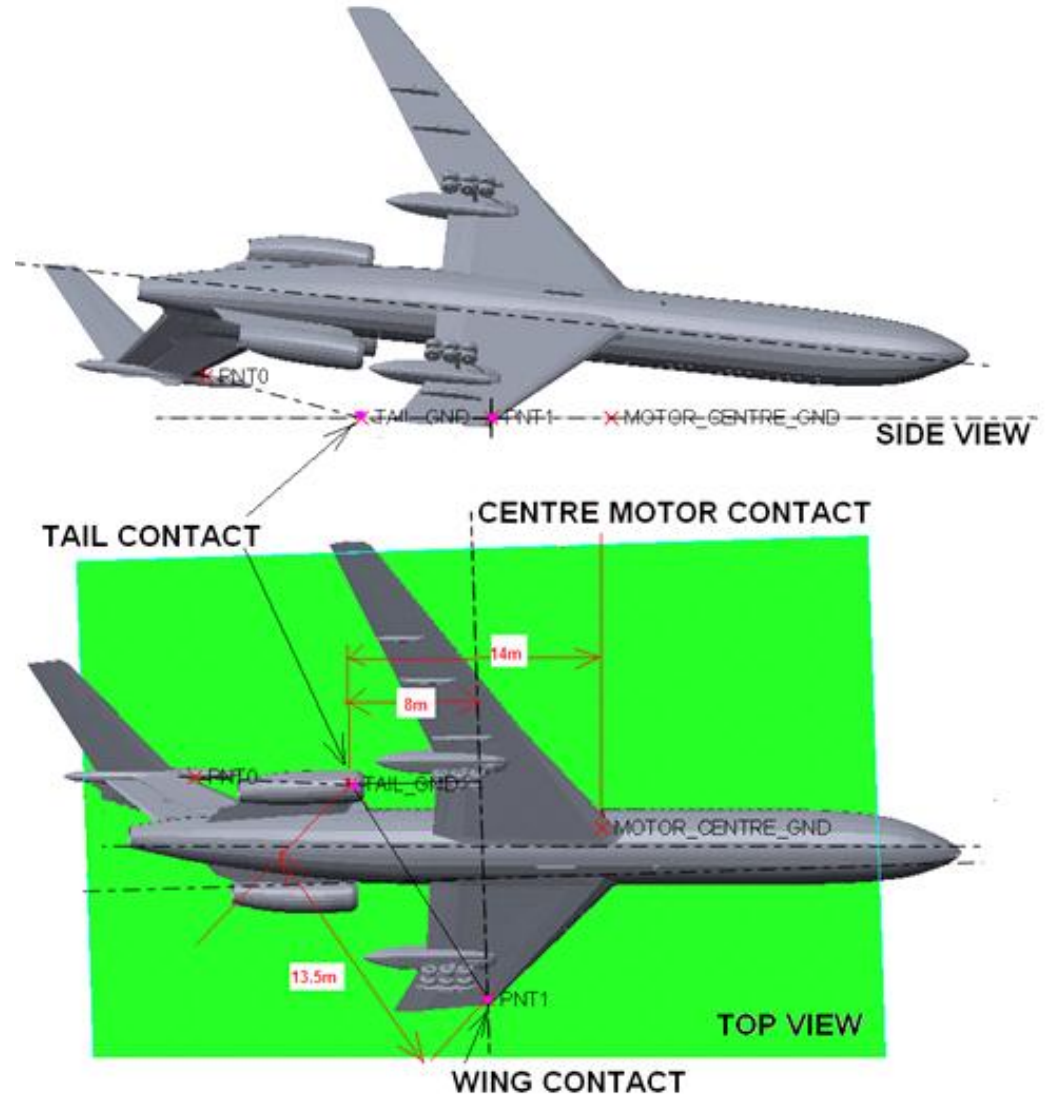
ORIENTATION OF PLANE AT CRASH (CASE II)

- 132° ROLL,
- -6° INCLINATION,
- $\epsilon \approx -15\text{deg}$,

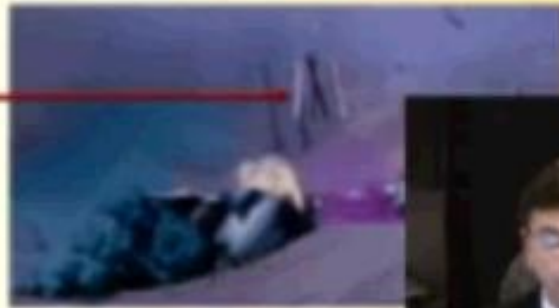
Simulation Agreed with FAA Experiment

- Inboard pole is cut by the wing
- Inboard tank compromised after impact with ground
- Outboard tank damaged by impact with the second pole, outboard pole is also cut
- Both poles fell in the direction of the airplane movement

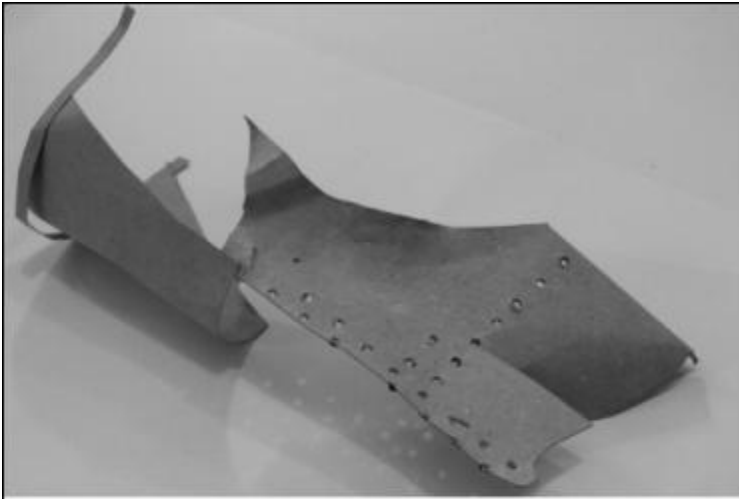
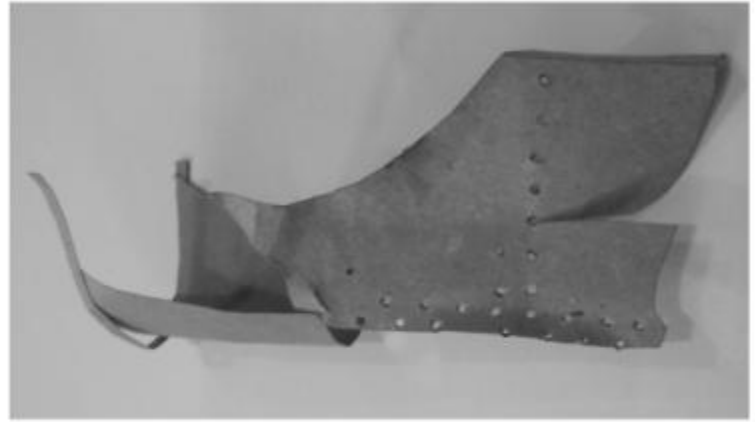
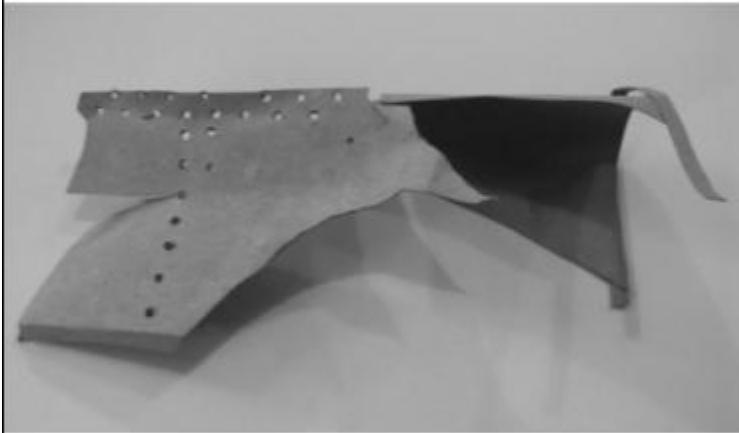
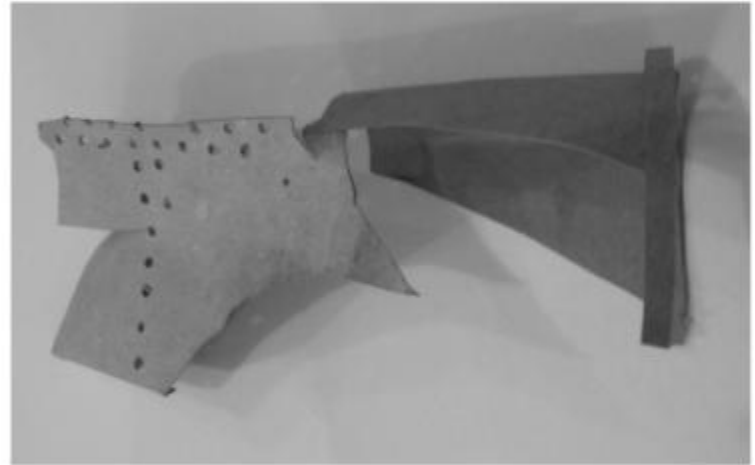
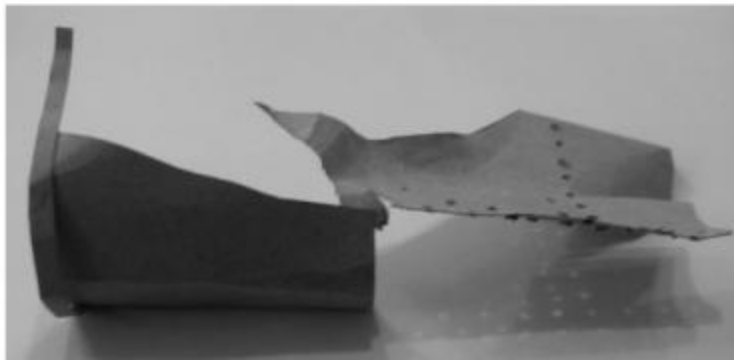
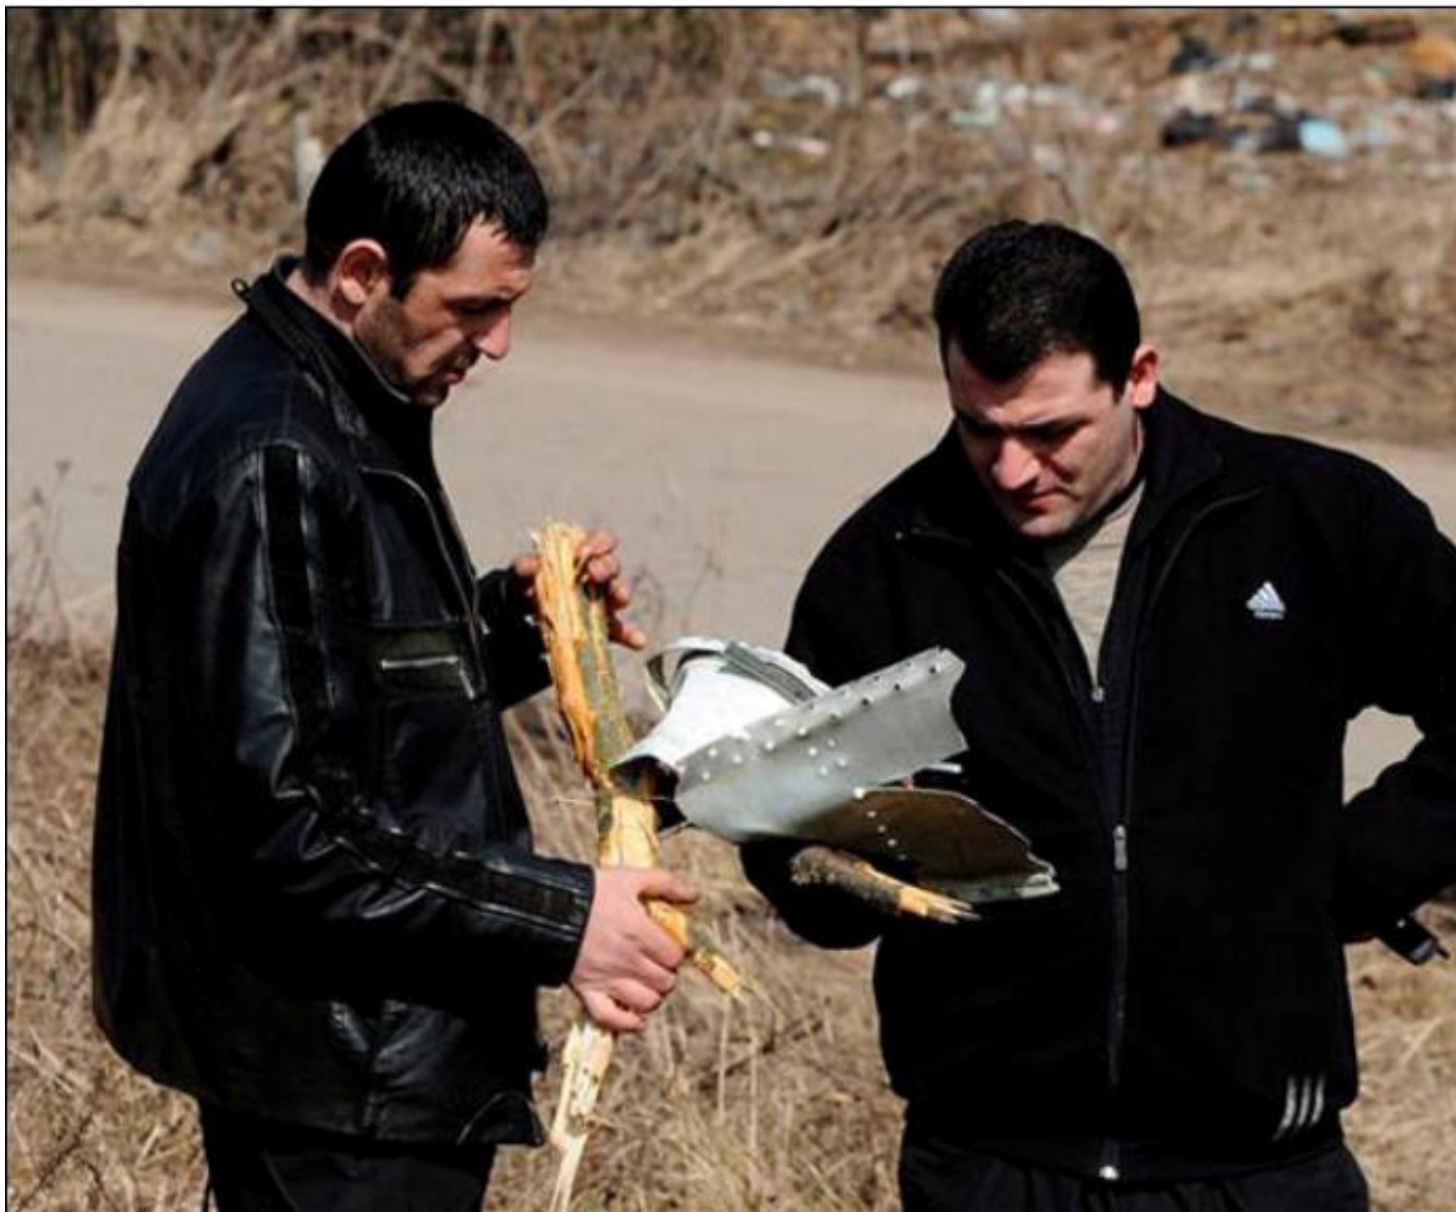
A section of the fuselage of P101 was found in the state shown to the right. Simulations show this only occurs in case the fuselage has been opened prior to final ground contact.
